7/17/06

MONTANA AVIATION SYSTEM PLAN
2006 UPDATE - PAVEMENT CONDITION INDEXES

DAWSON COMMUNITY AIRPORT

GLENDAIVE
MONTANA

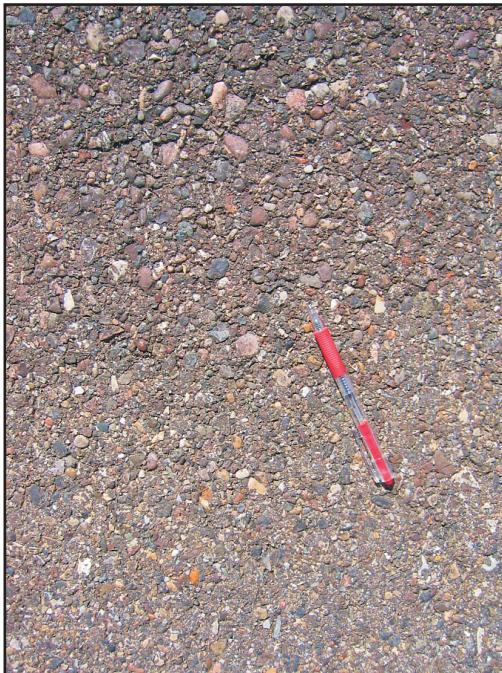
T-2, surface detail, fuel spill

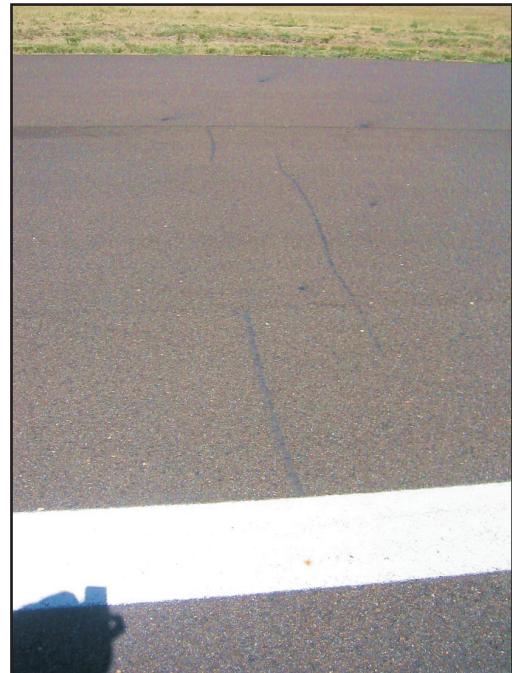
R-3, overview

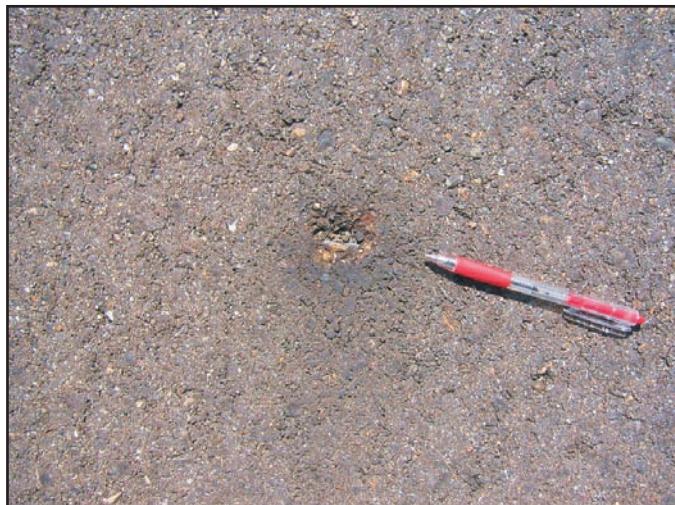
R-3, surface detail with pop-out

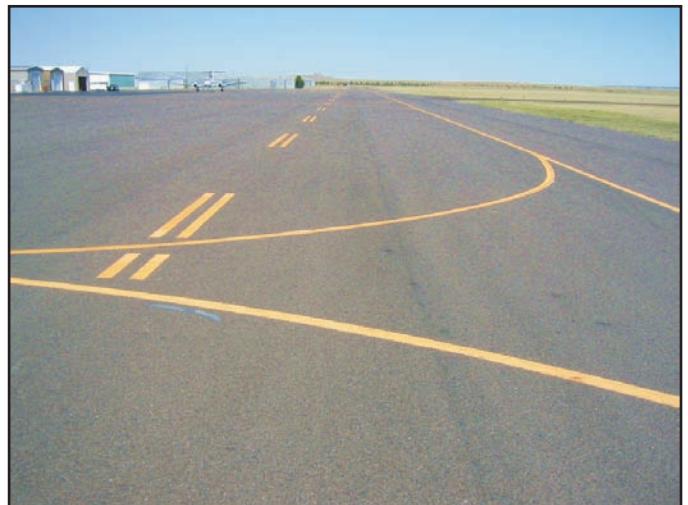
A-1, overview

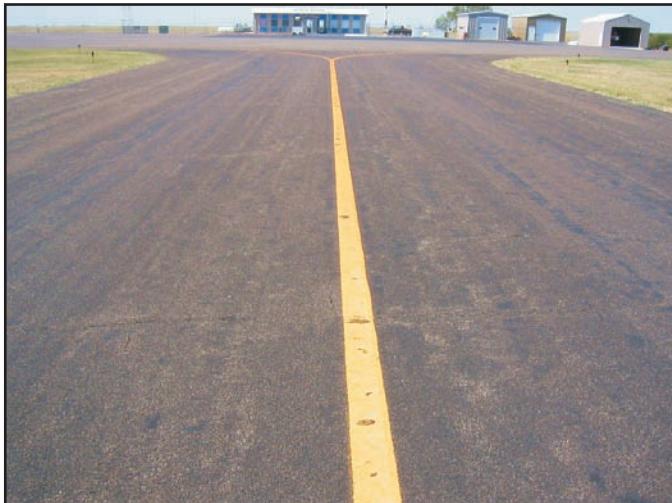
T-1, overview

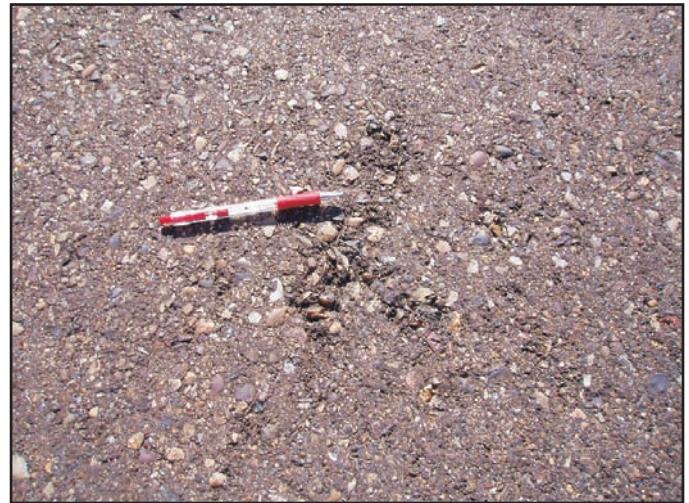
A-1, surface detail with void

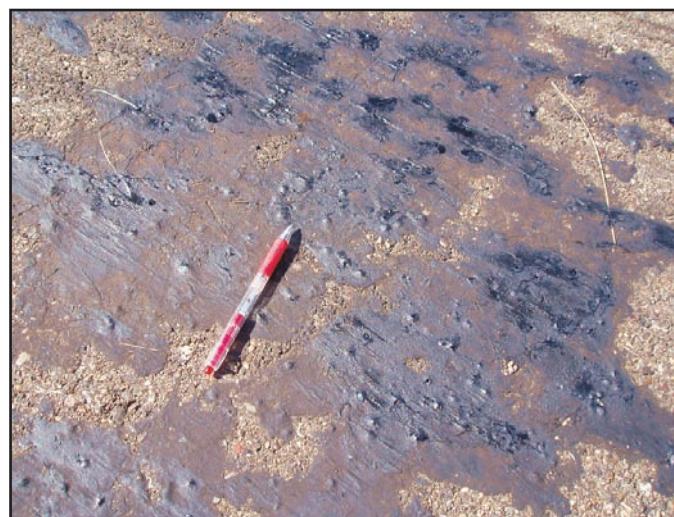
A-2, bleeding
